Debris/Ice/TPS Assessment And Photographic Analysis For Shuttle Mission STS-31R

June 1990

Charles G. Stevenson
NASA/Kennedy Space Center

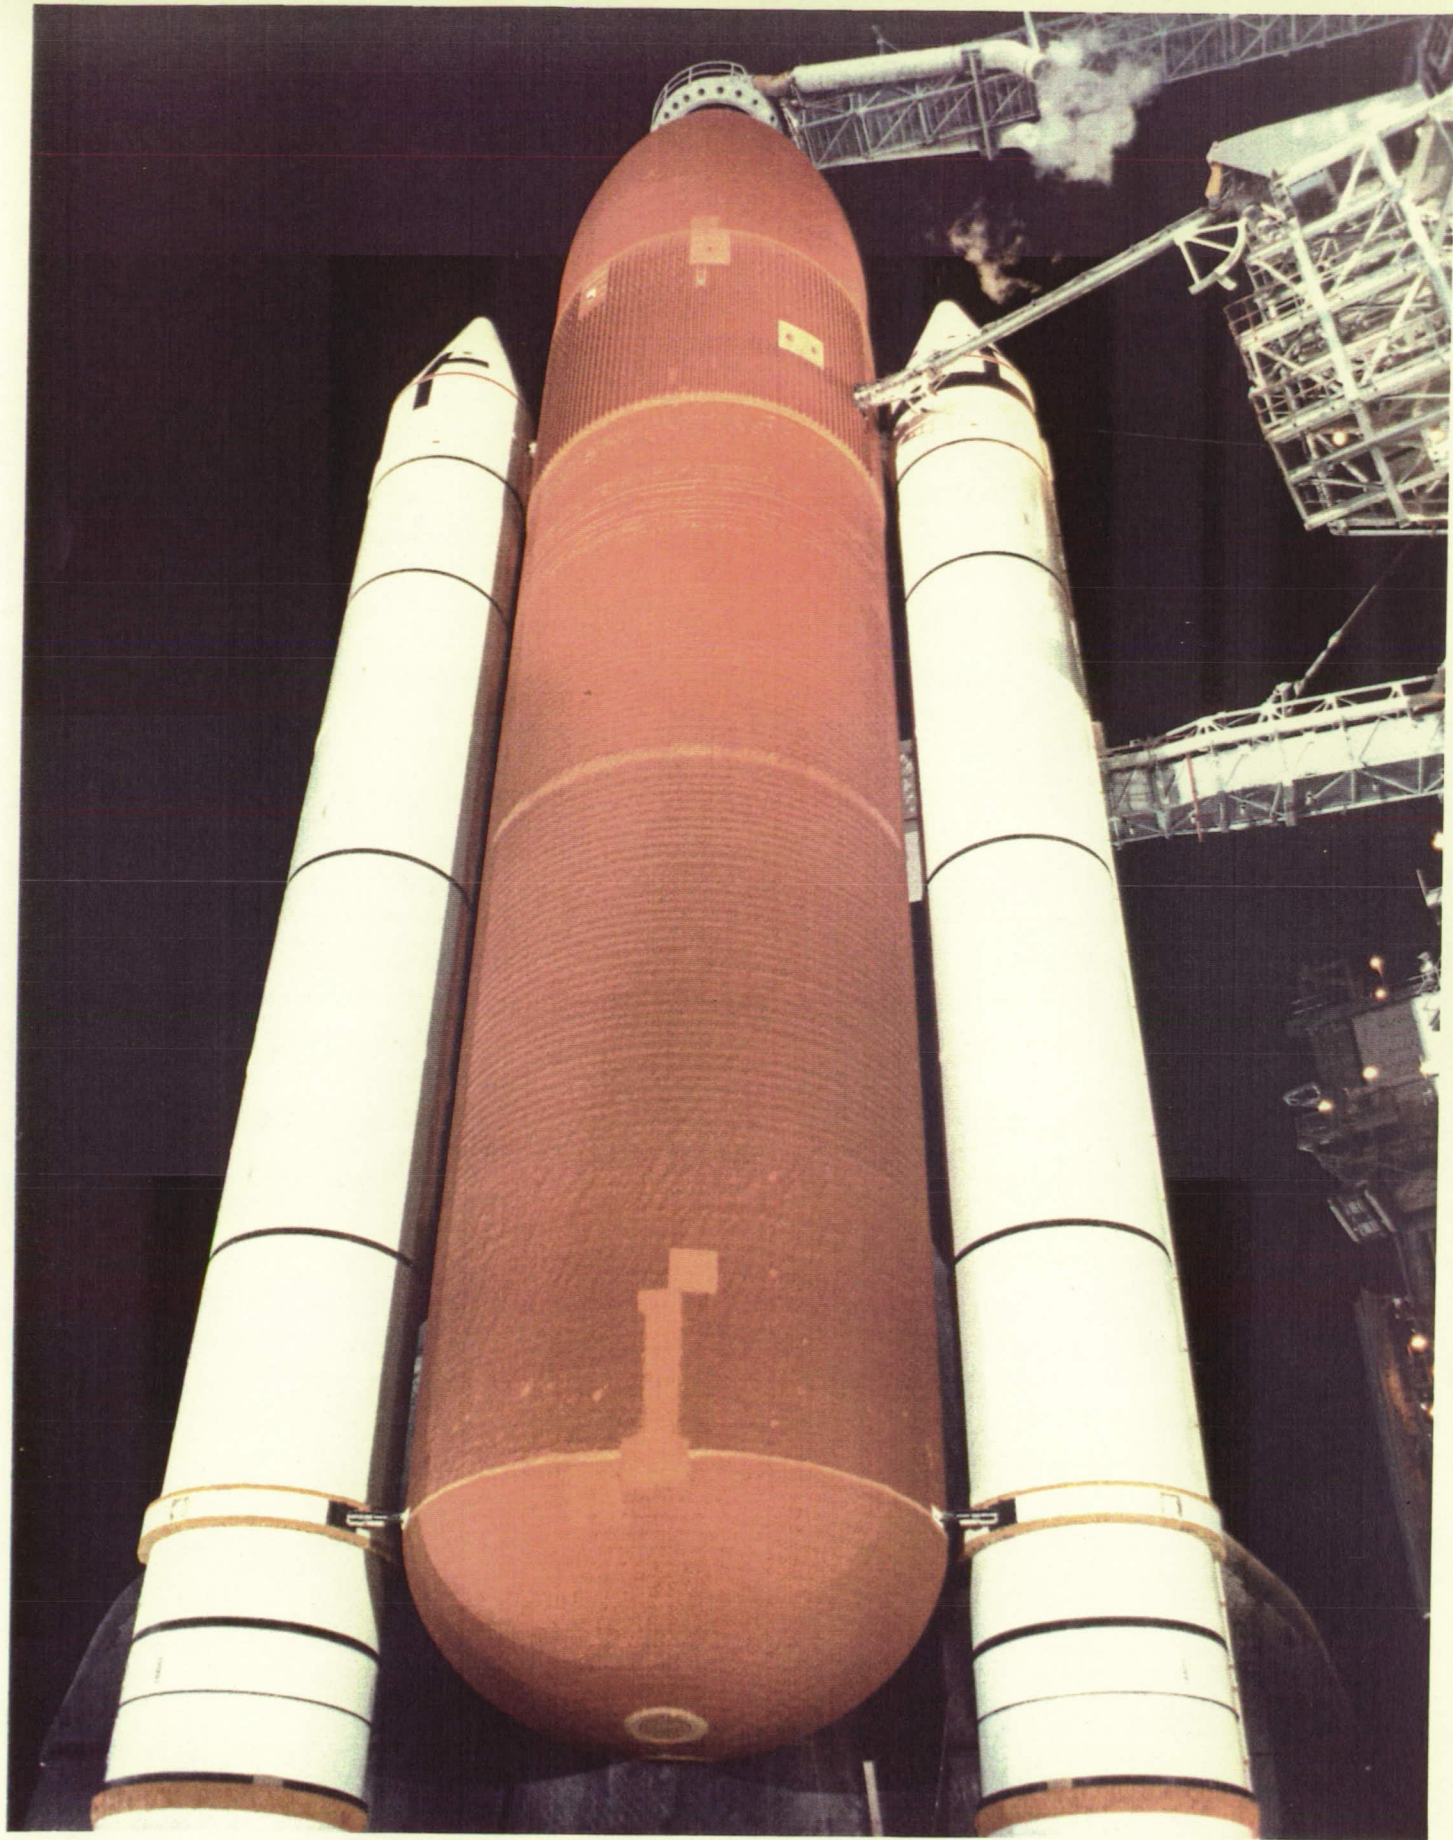
Overall view of ET-34 -Z side. There were no acreage TPS defects or anomalies

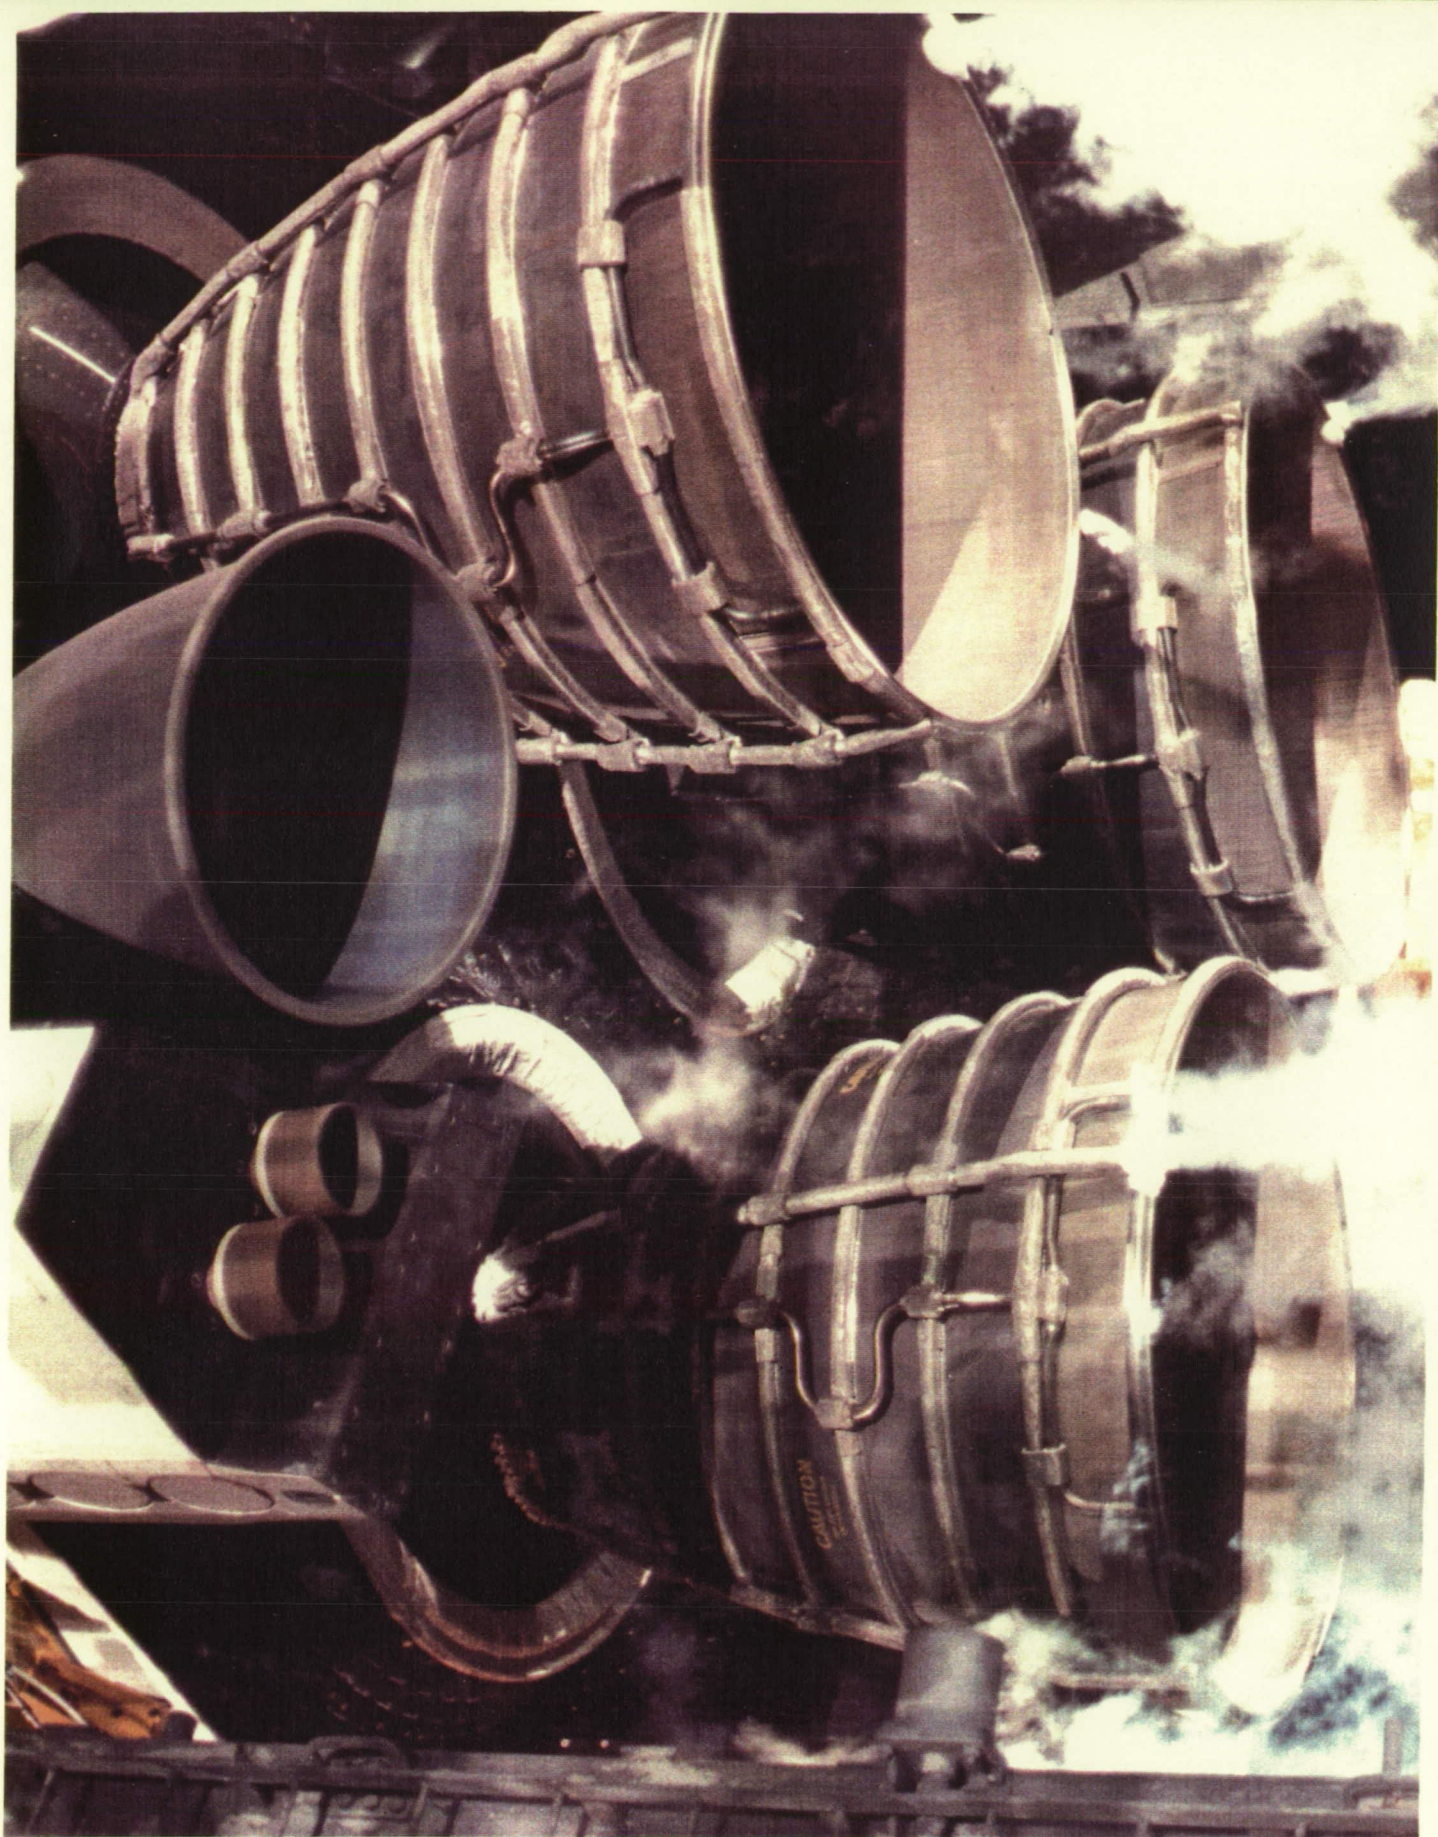
Overall view of SSME's. Note appearance of ice/frost at the
SSME #2 engine mounted heat shield interface.

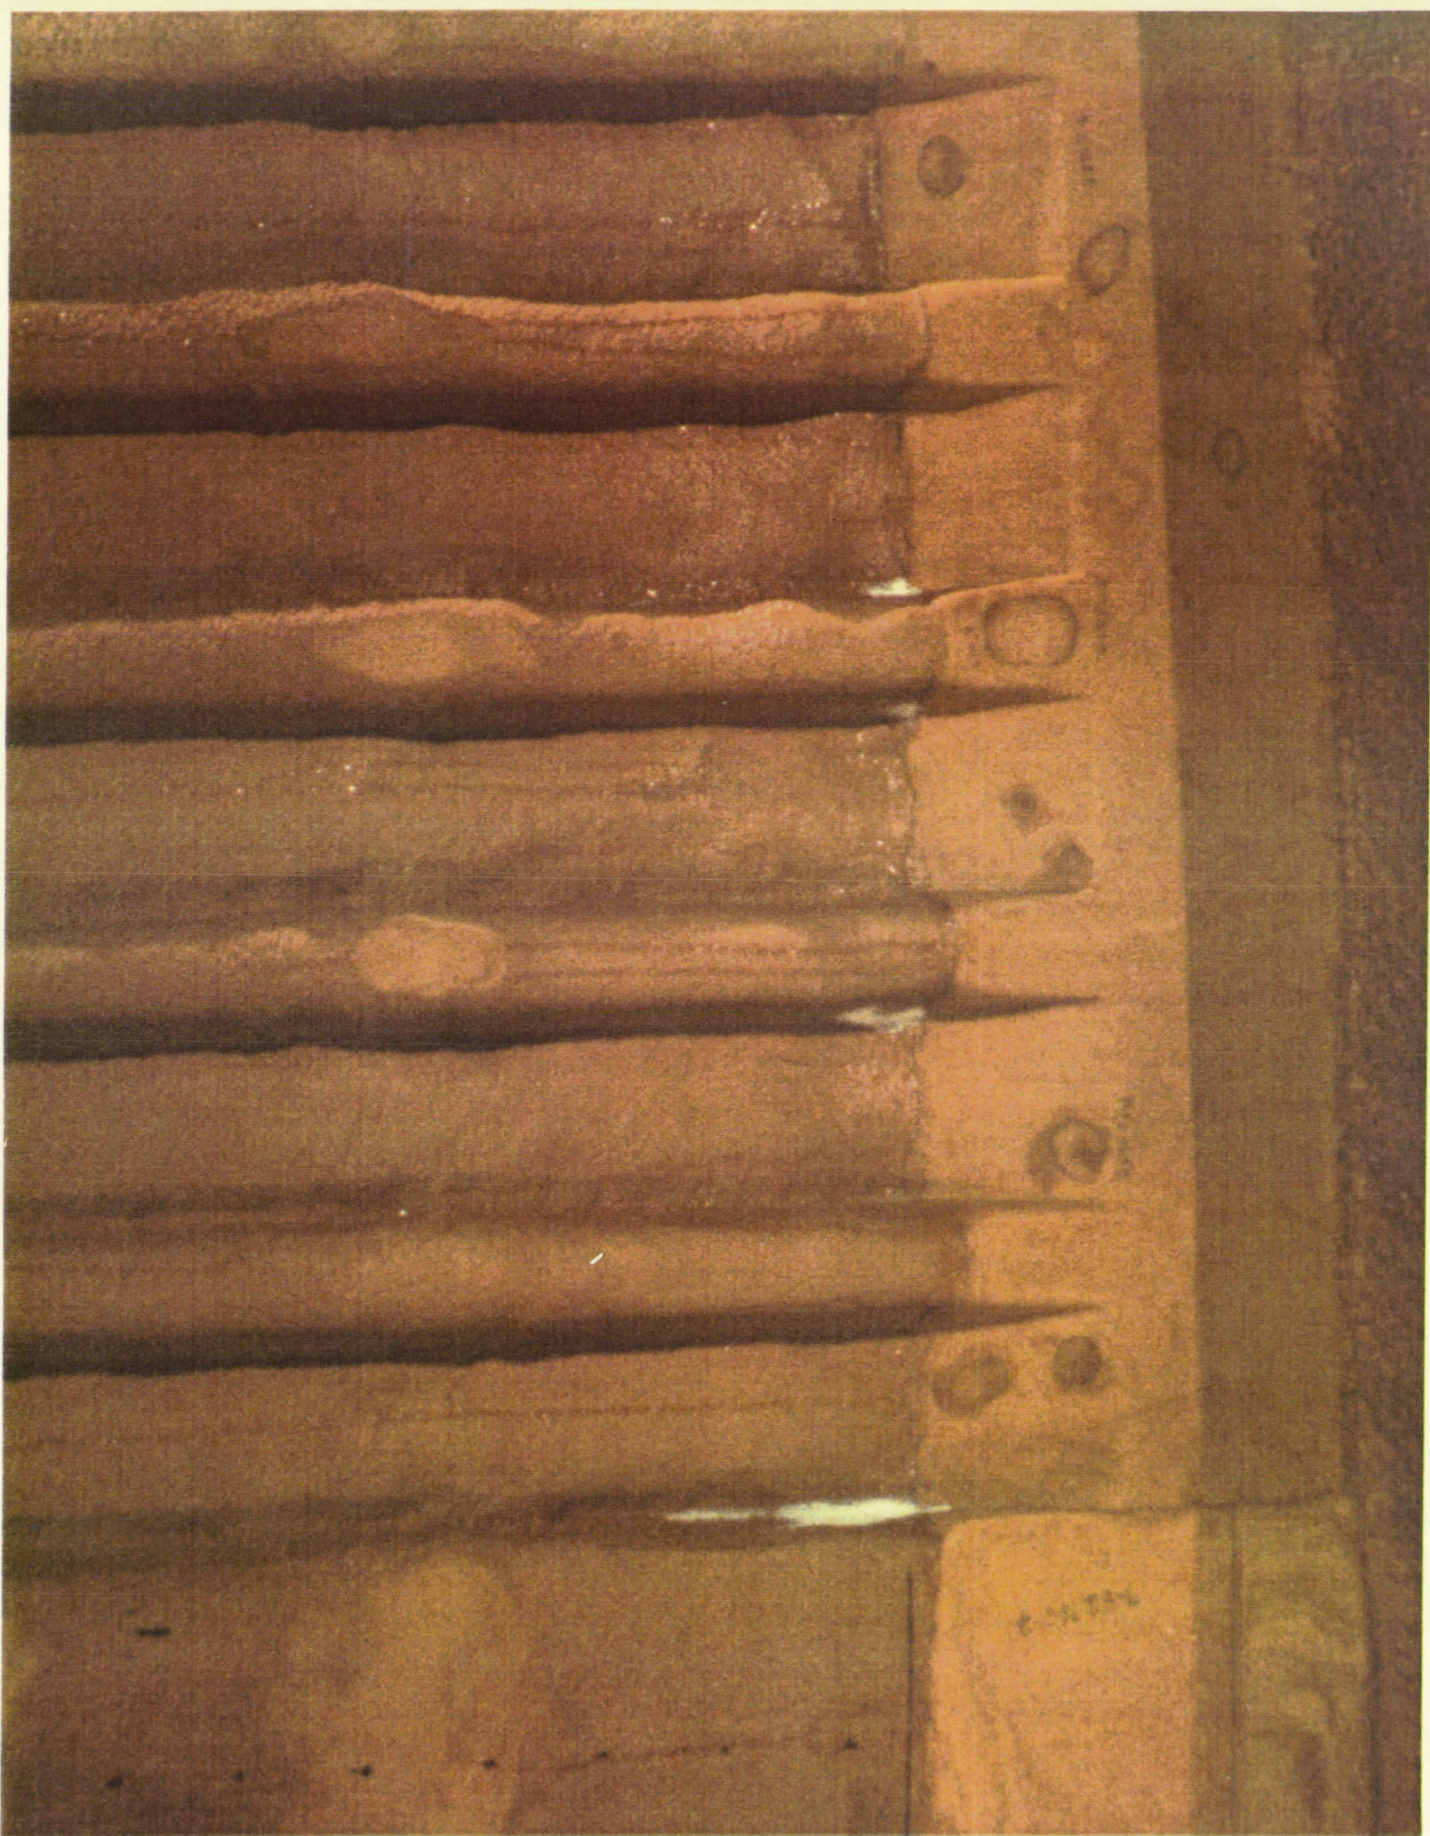
Frost accumulations in the intertank stringer valleys occurred
on the -Z side of the tank

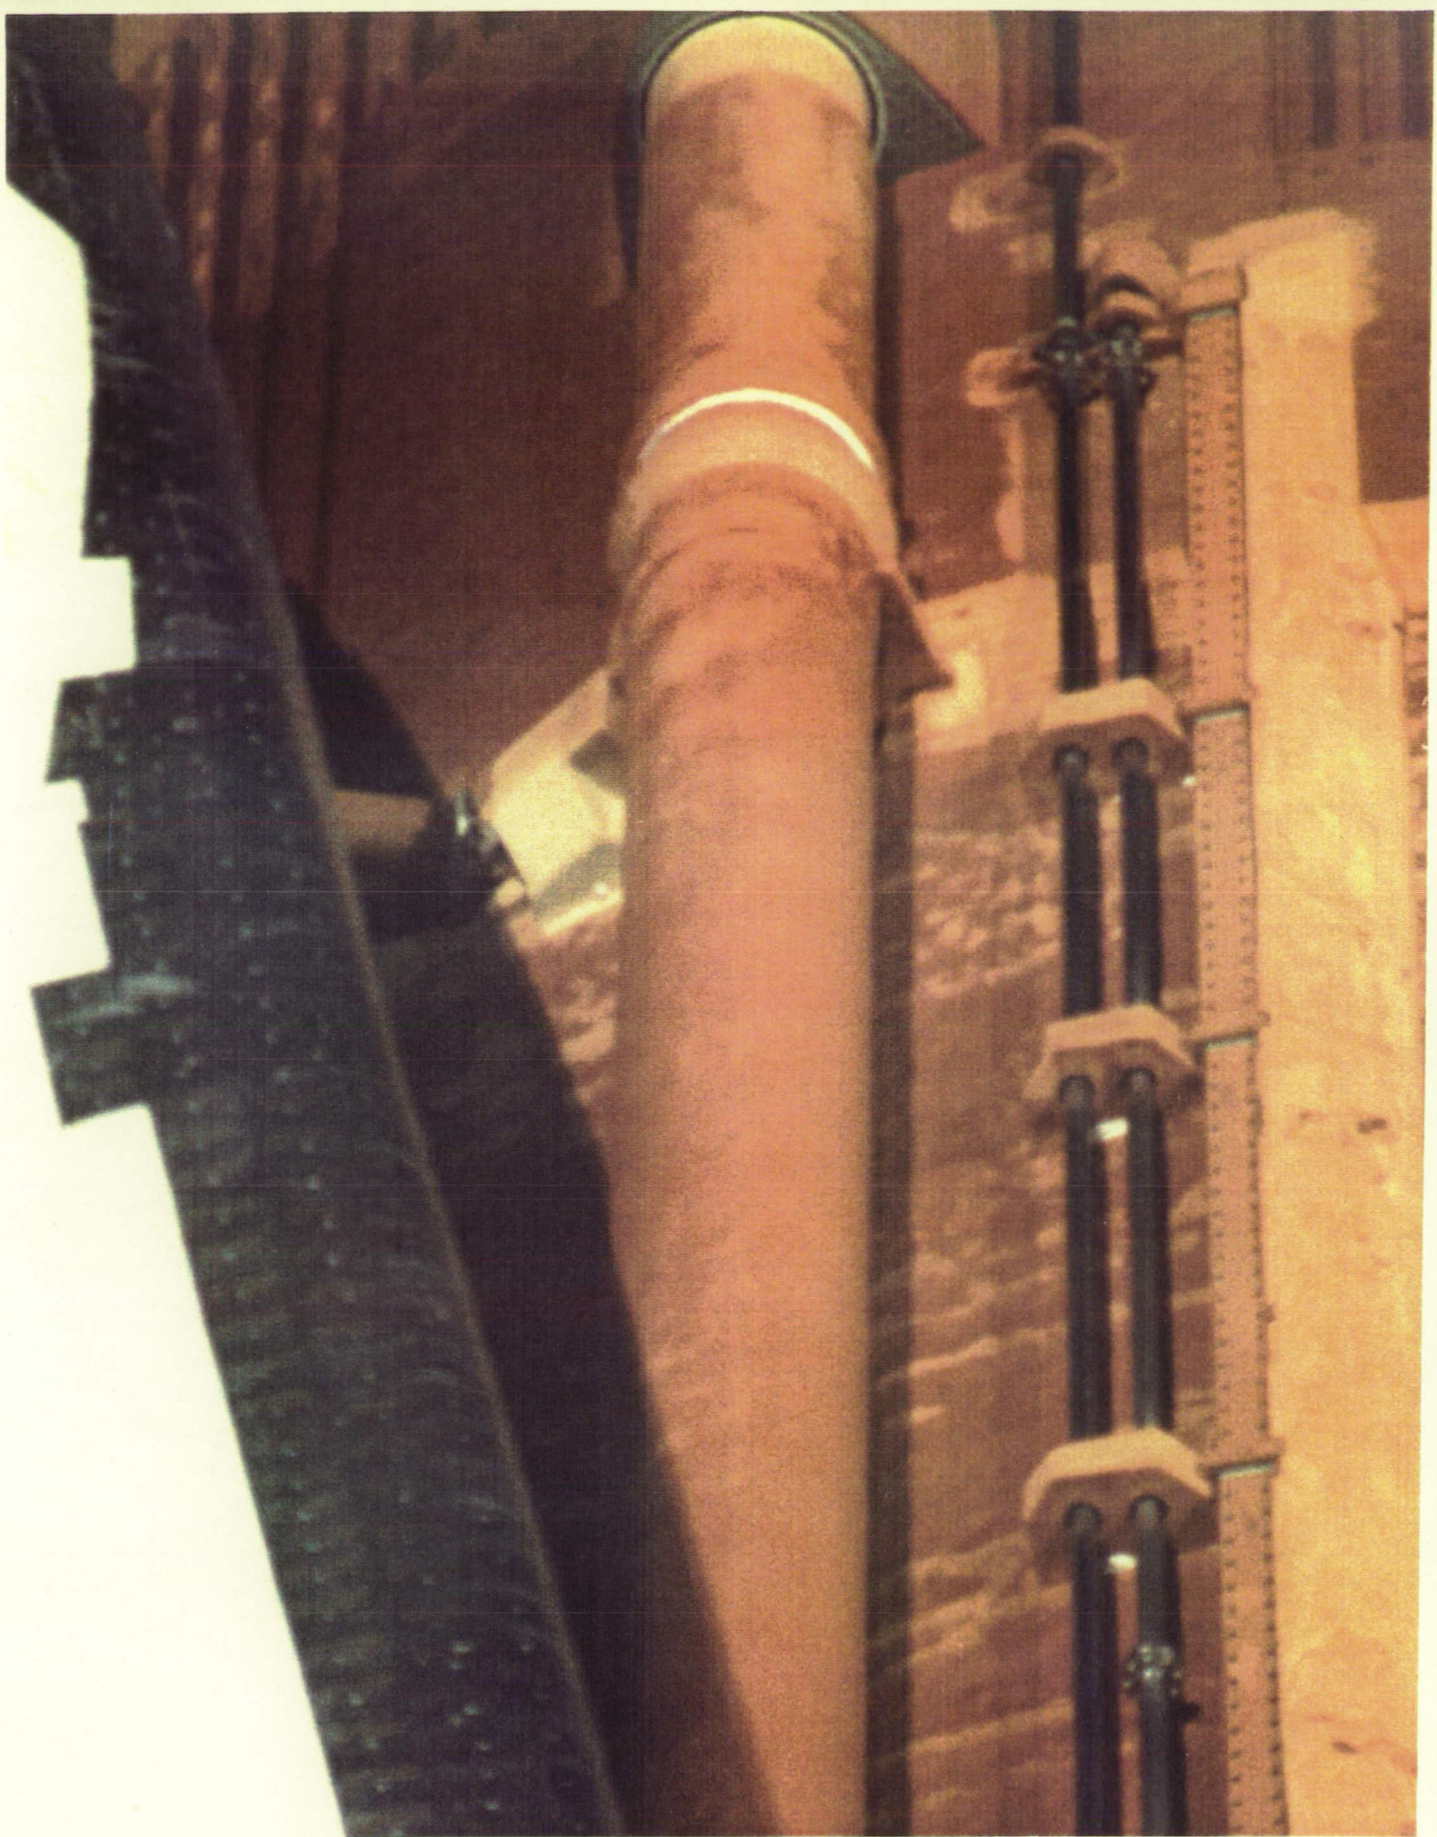
Typical amount of ice formed in the L02 feedline upper bellows.
Ice/frost also formed along aft sides of the ice/frost ramps.

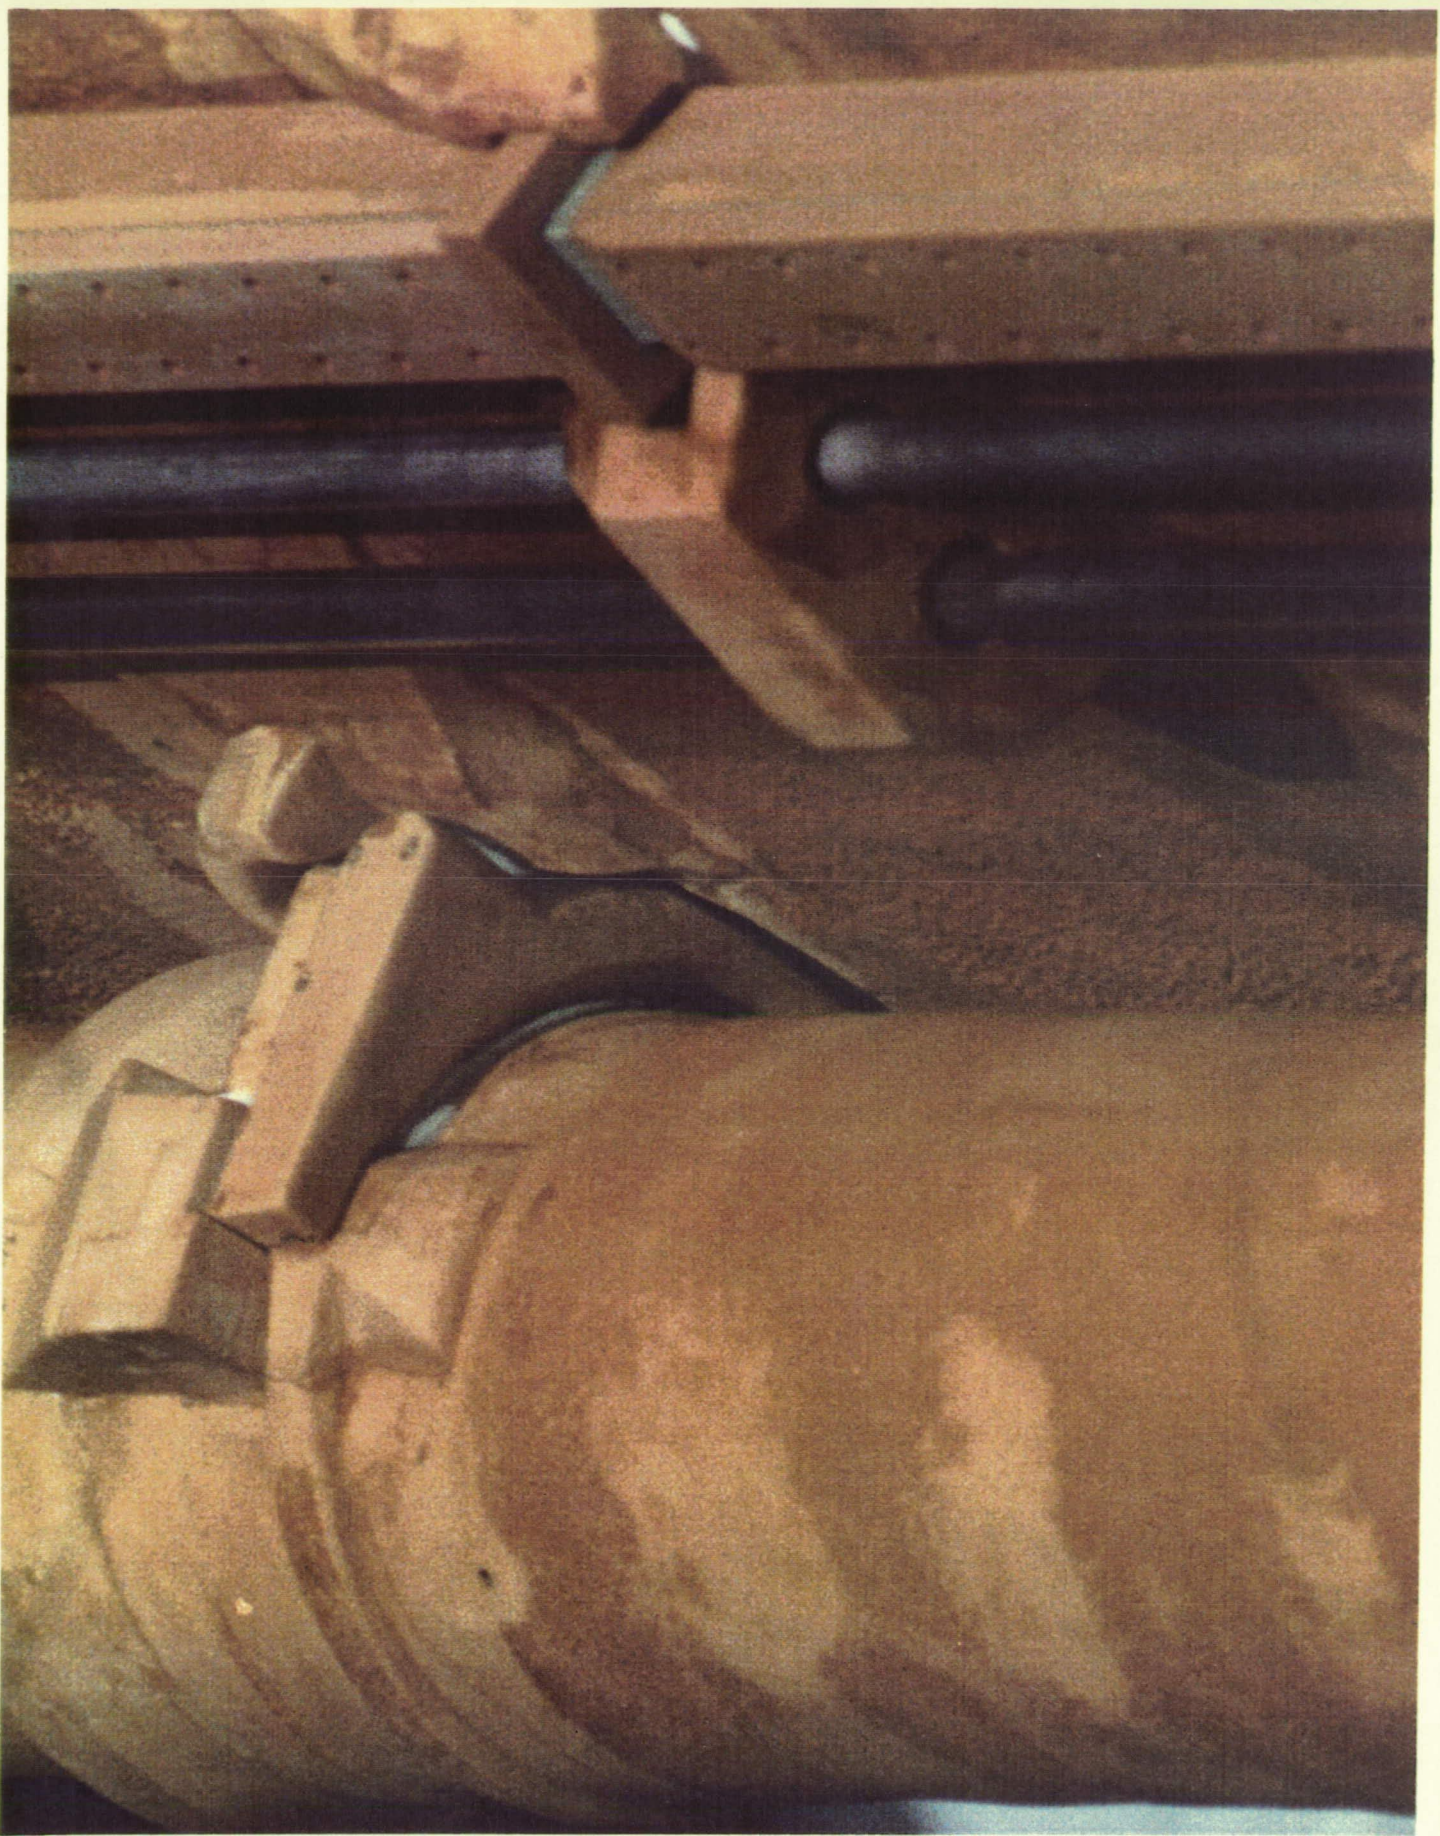
Typical accumulation of ice/frost in the L02 feedline support bracket. Note frost spot along aft side of ice/frost ramp.

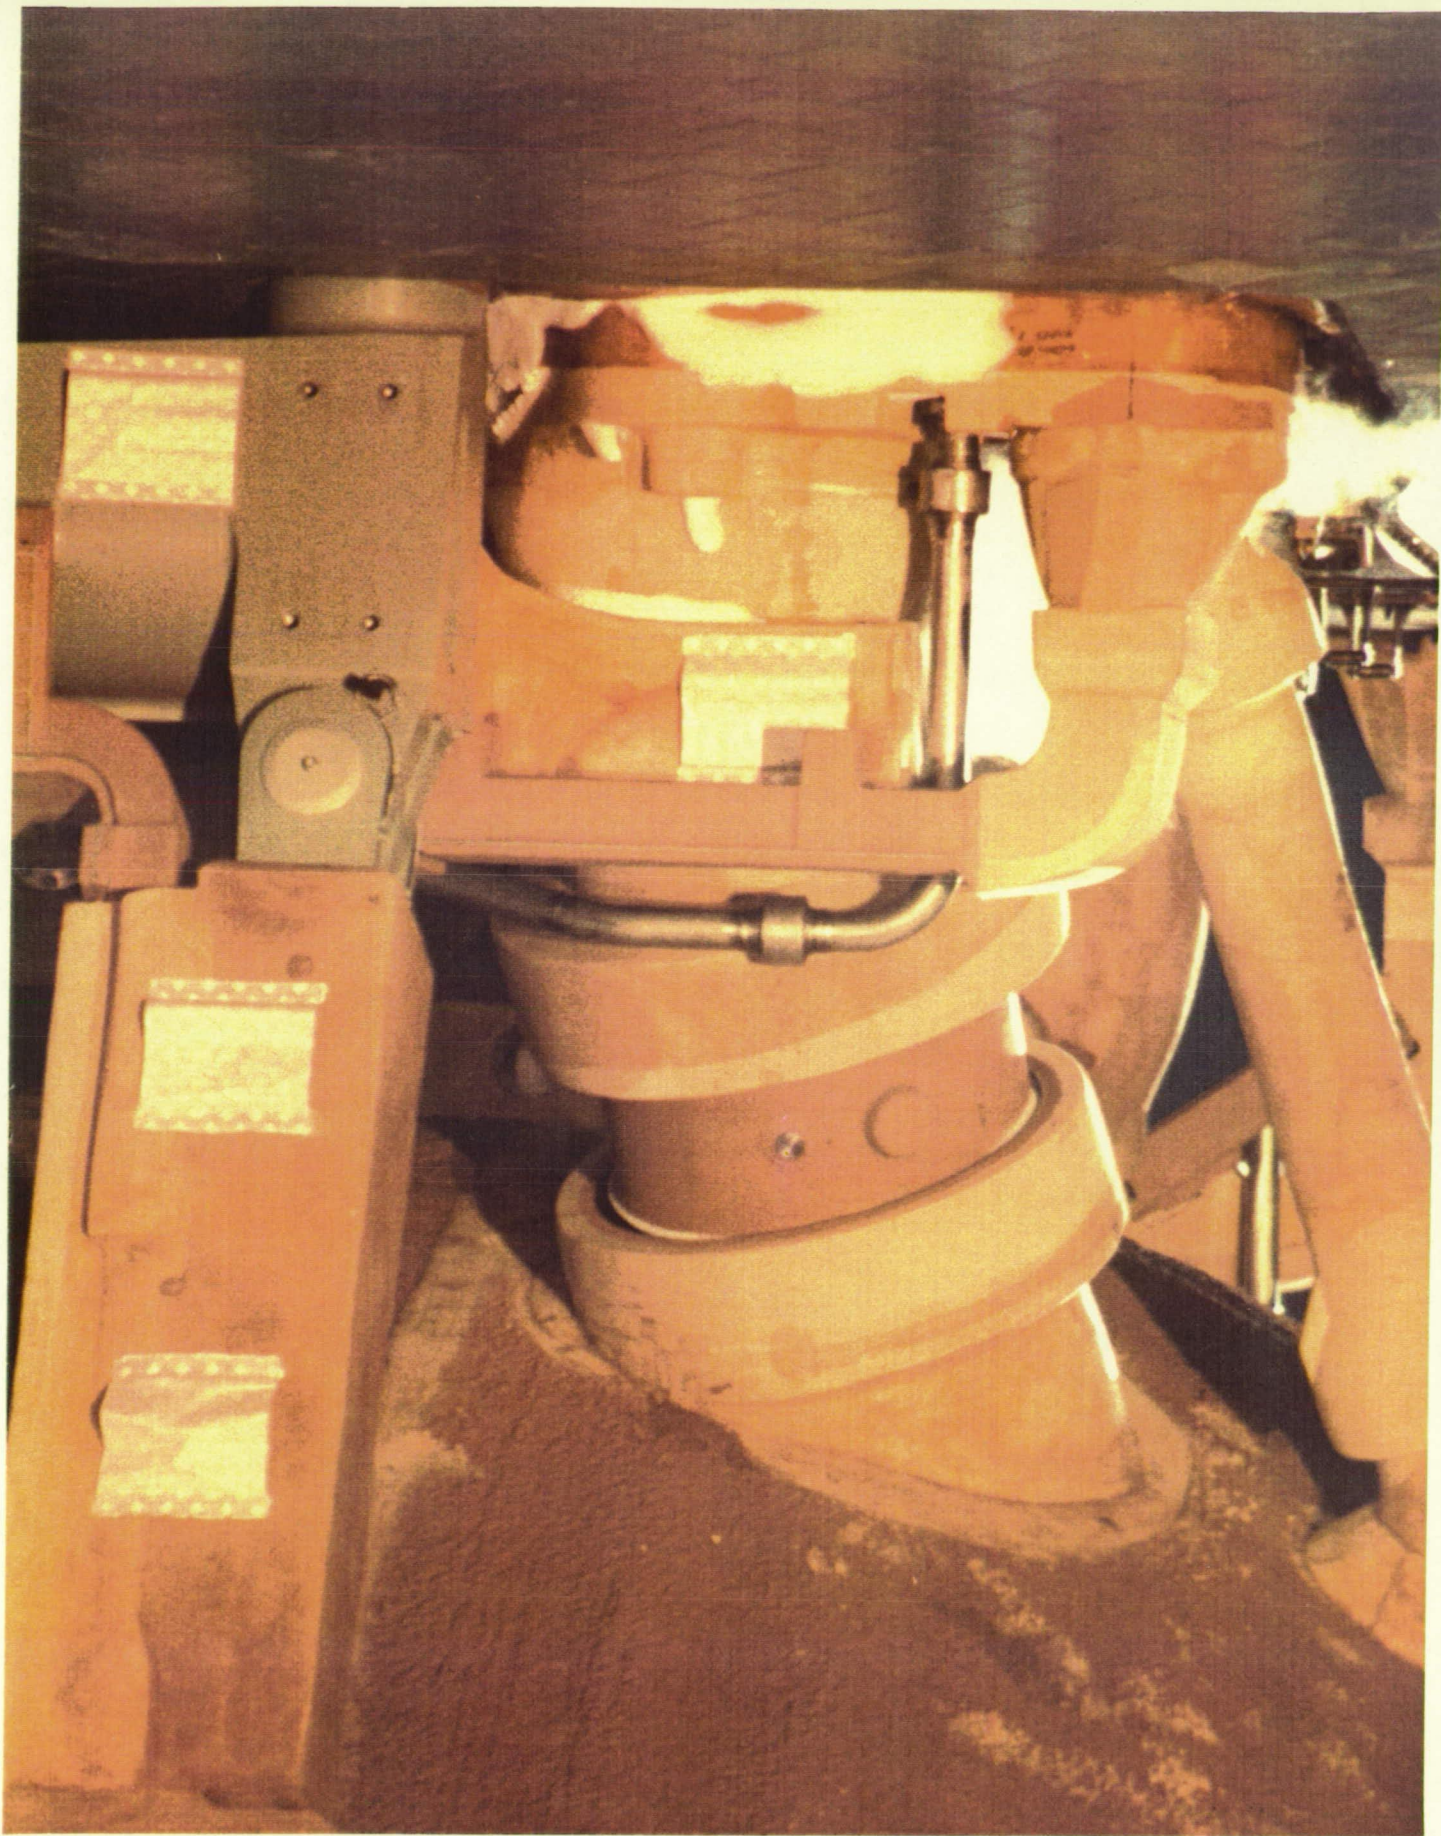
Overall view of LH2 ET/ORB umbilical. Venting of purge gas from the inboard purge vents is a normal occurrence.

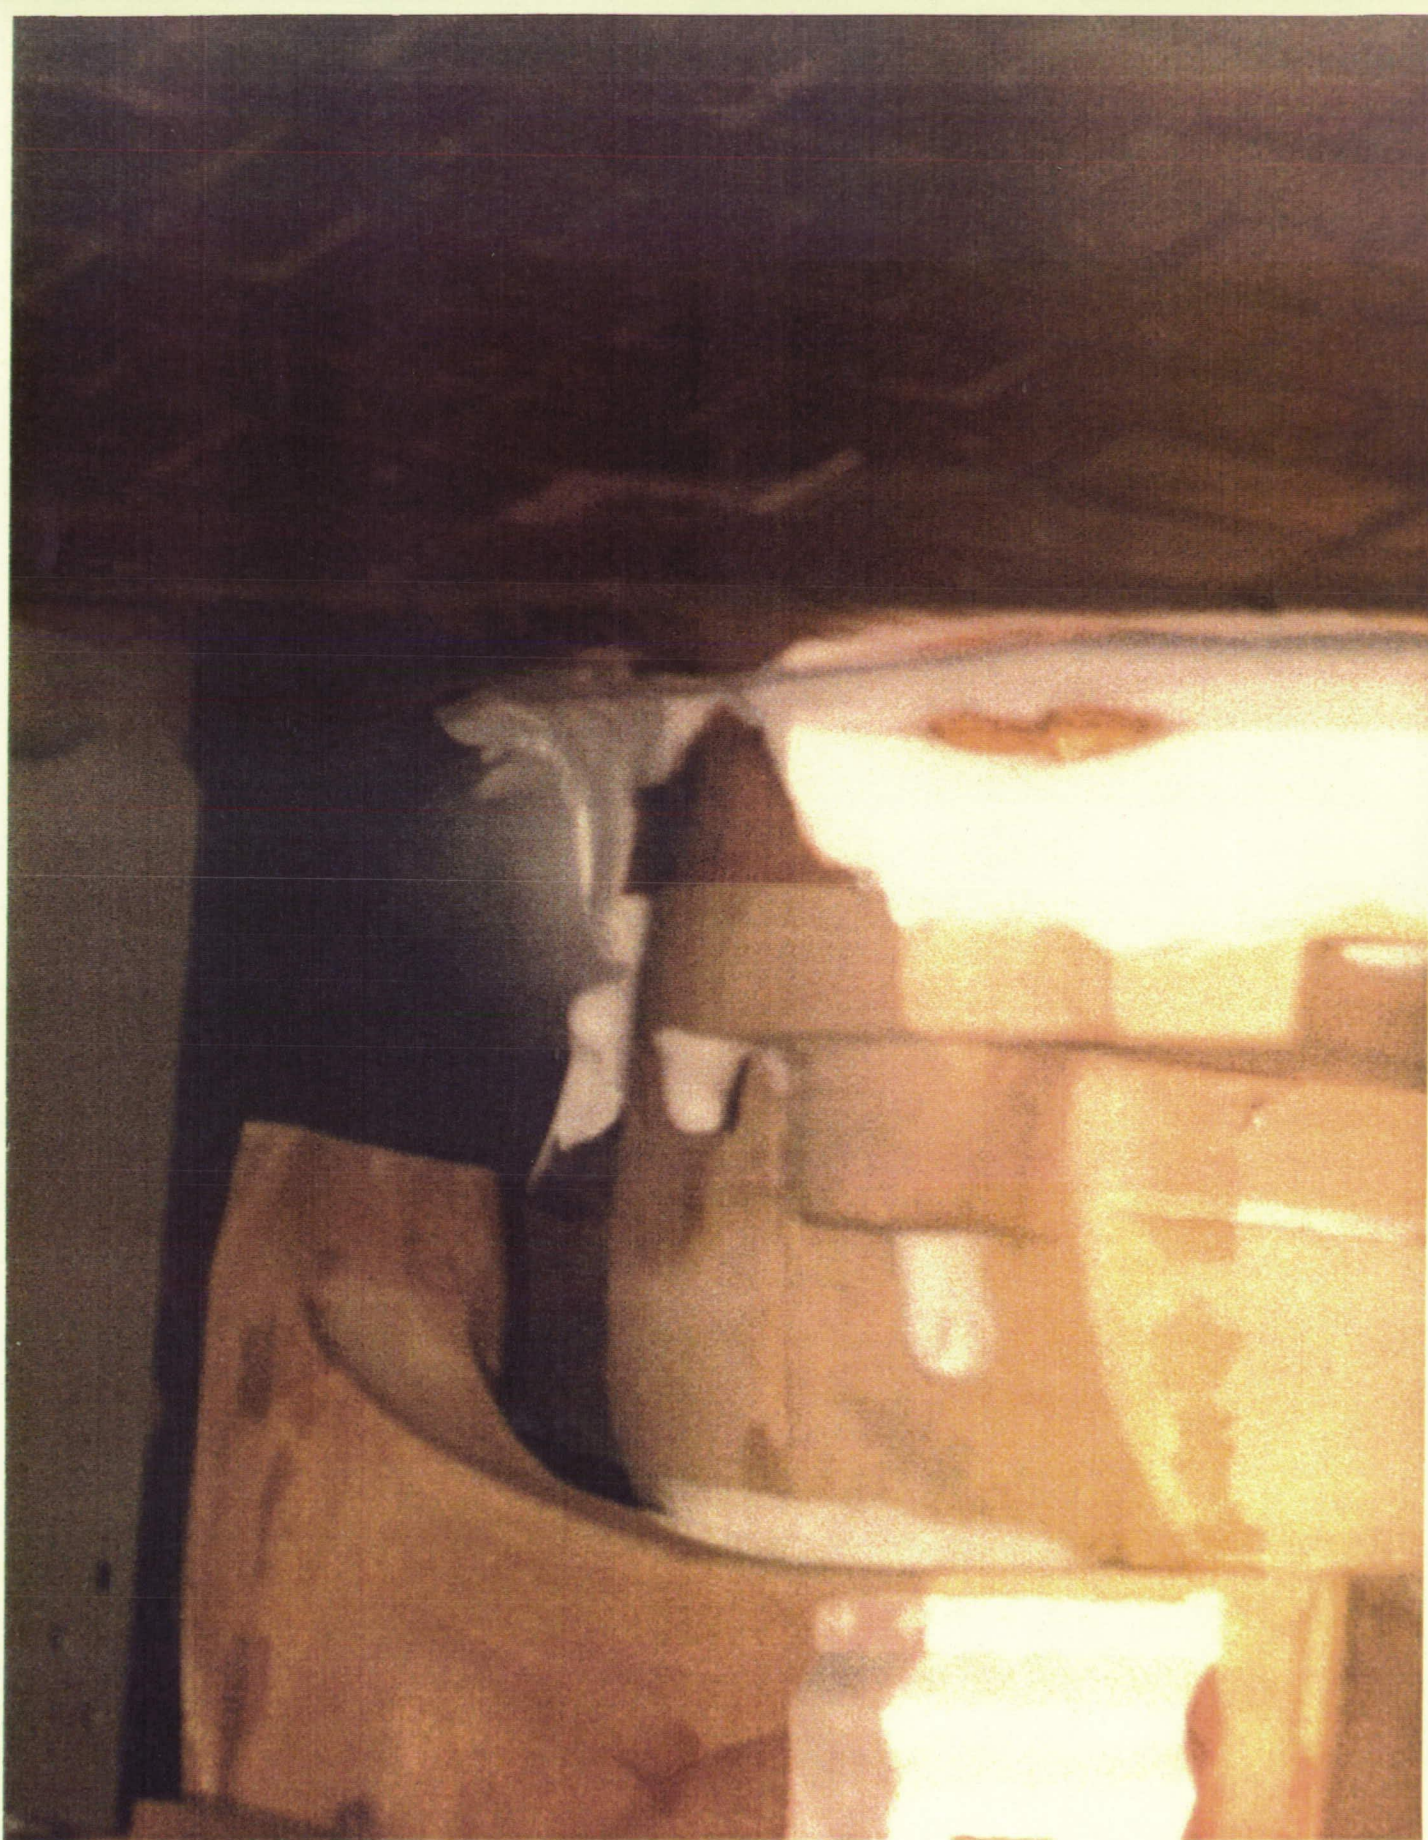
Ice/frost has formed on the purge vents, around the LH2 feedline, and on the top and side of the LH2 umbilical

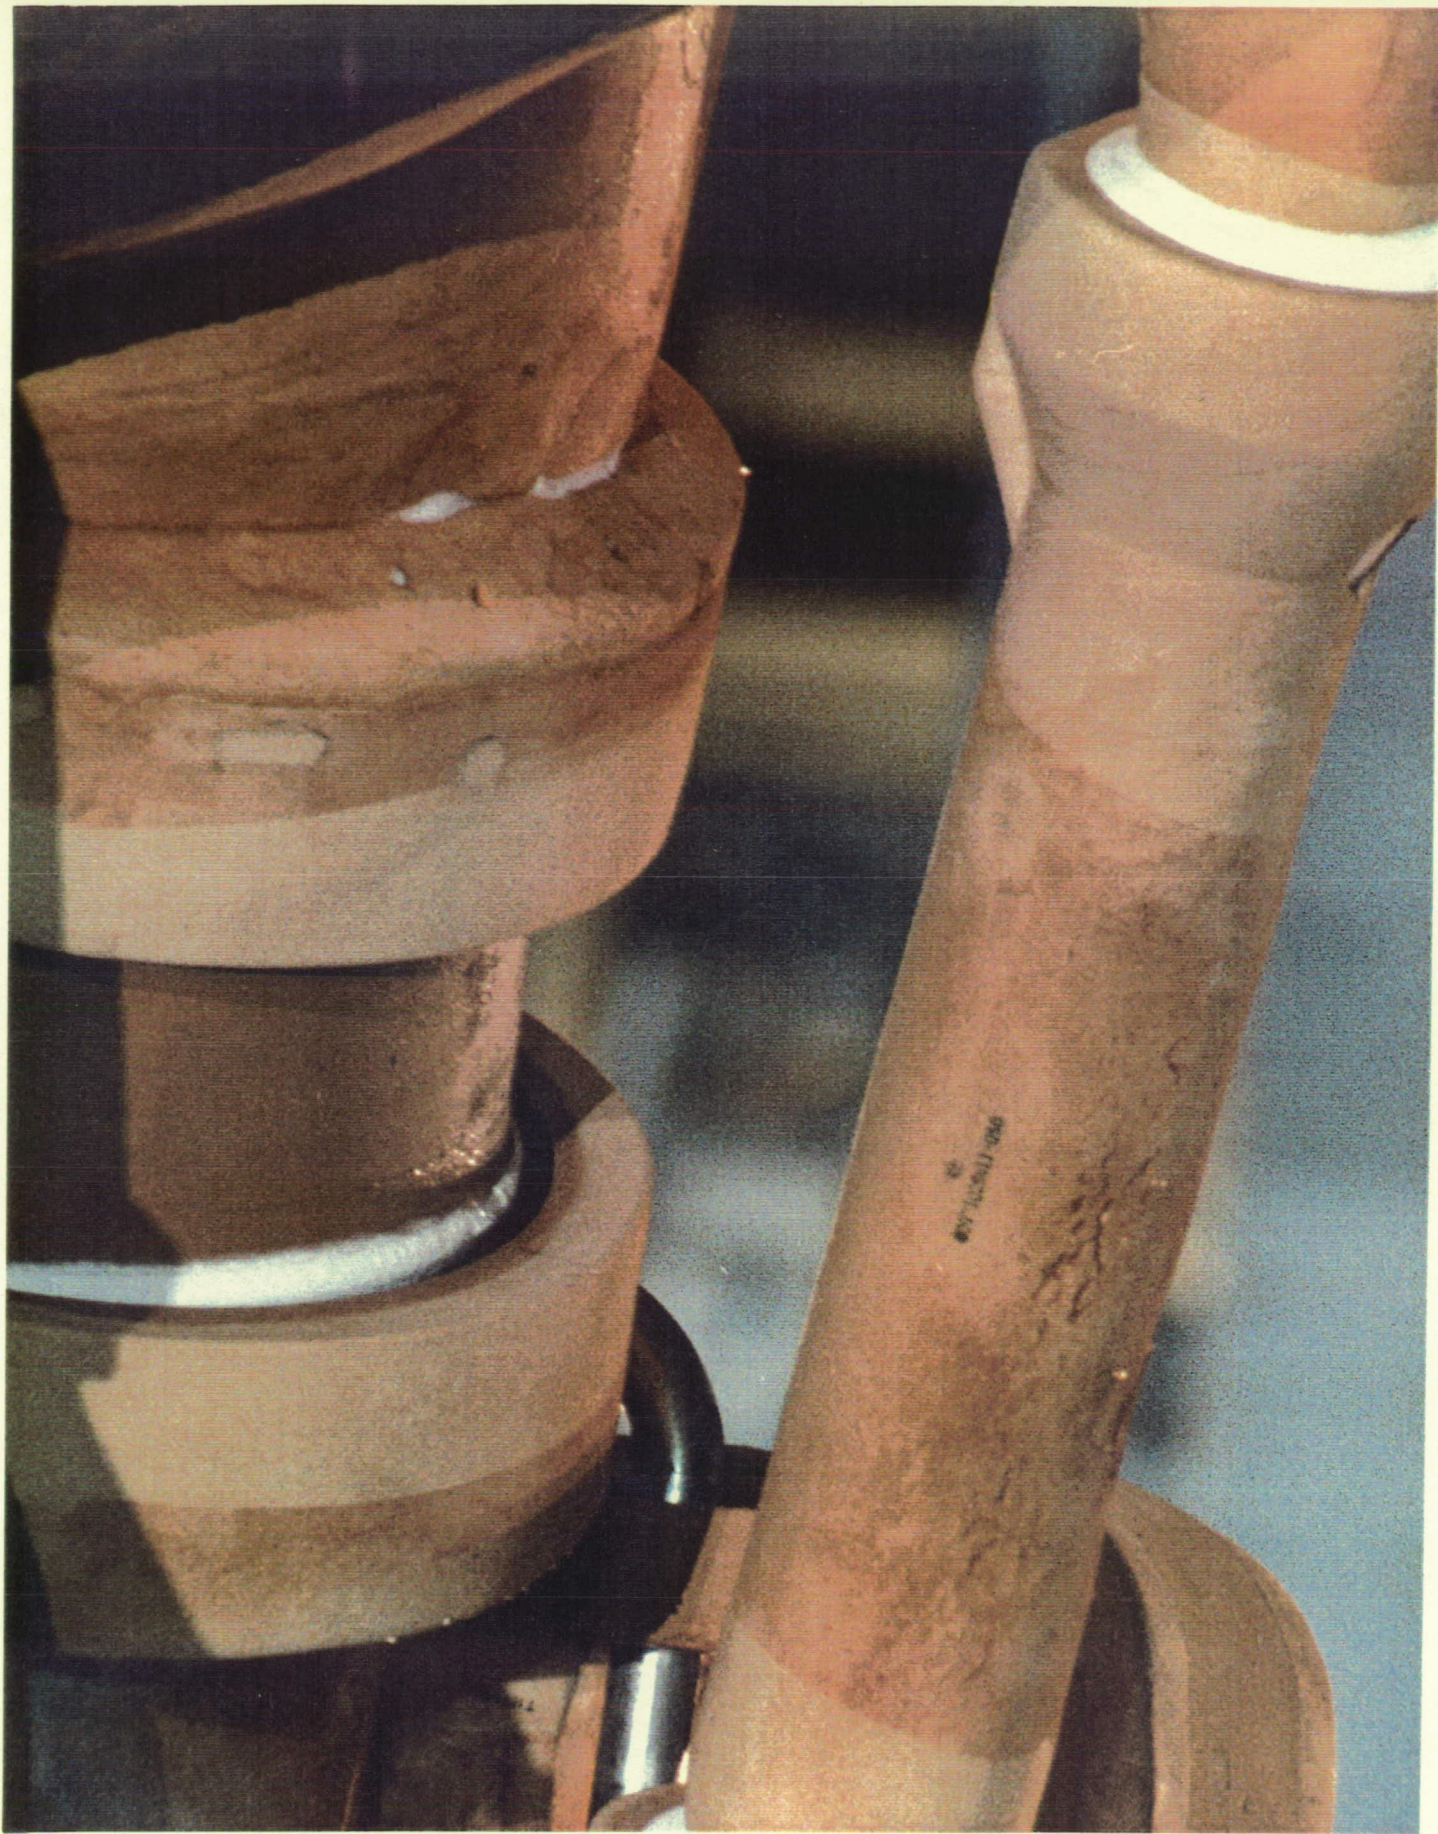
Ice/frost in the LH2 feedline and recirculation line bellows is normal. Two frost spots formed on the F/L flange closeout.
